ASSESSMENT AND RENEWAL OF THE CENTENNIAL BRIDGE

Abstract: The Centennial Bridge, located in Miramichi, NB, was constructed in the 1960s when winter concreting practices were less advanced than modern practice. Major repairs and upgrades are currently underway to bring the structure in line with current standards and prolong its useful life. The Bridge is a 1.1 km long bridge spanning the brackish waters of the Miramichi River. It is a steel superstructure bridge with twenty concrete piers. The bridge is located in a very demanding environment for construction materials; in addition to the impacts of deicer salts and frequent freezing and thawing periods, brackish water and tidal impacts affect the concrete river piers. Furthermore, the substructures are difficult to access; therefore, inspection and maintenance activities have been limited. Following the decision to upgrade and refurbish this structure to prolong its useful life, a multi-phase investigation and repair/upgrading program was undertaken. An investigation of the steel superstructure was undertaken by the structural consultant and upgrades and repairs were conducted between 2013 and 2017. These activities were planned

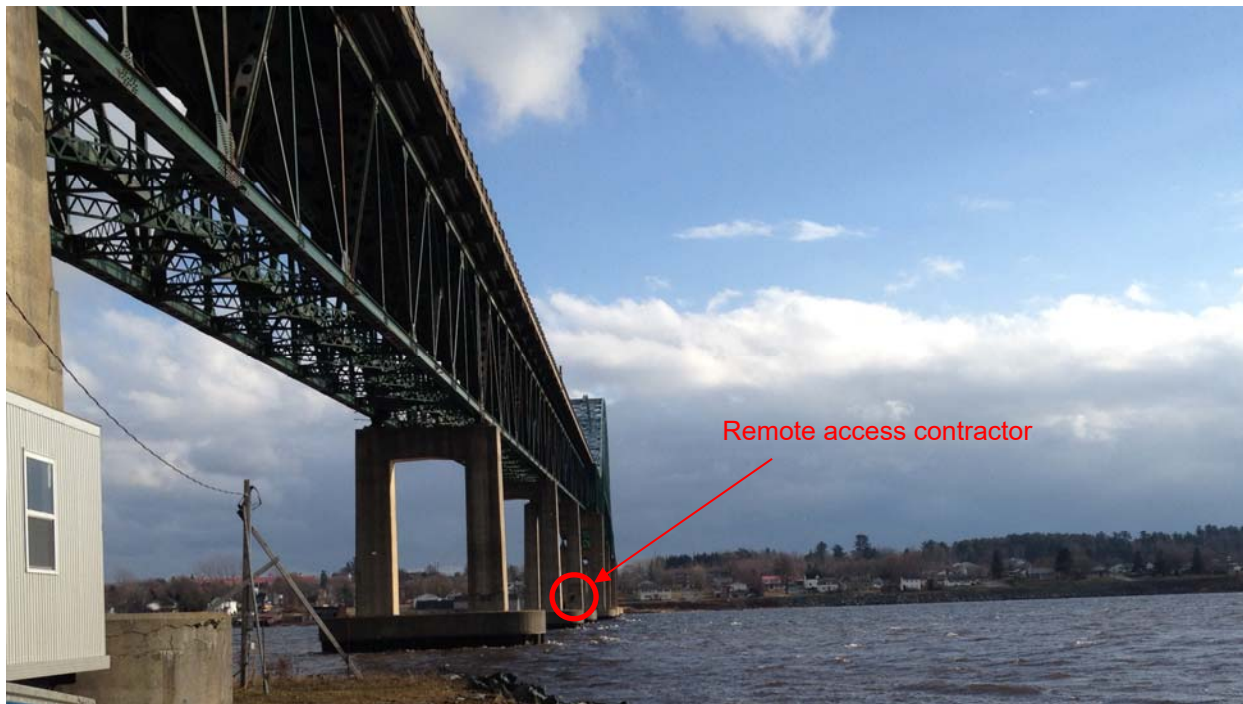
Figure 2: Remote Access Contractor Drilling Core from Concrete River Pier

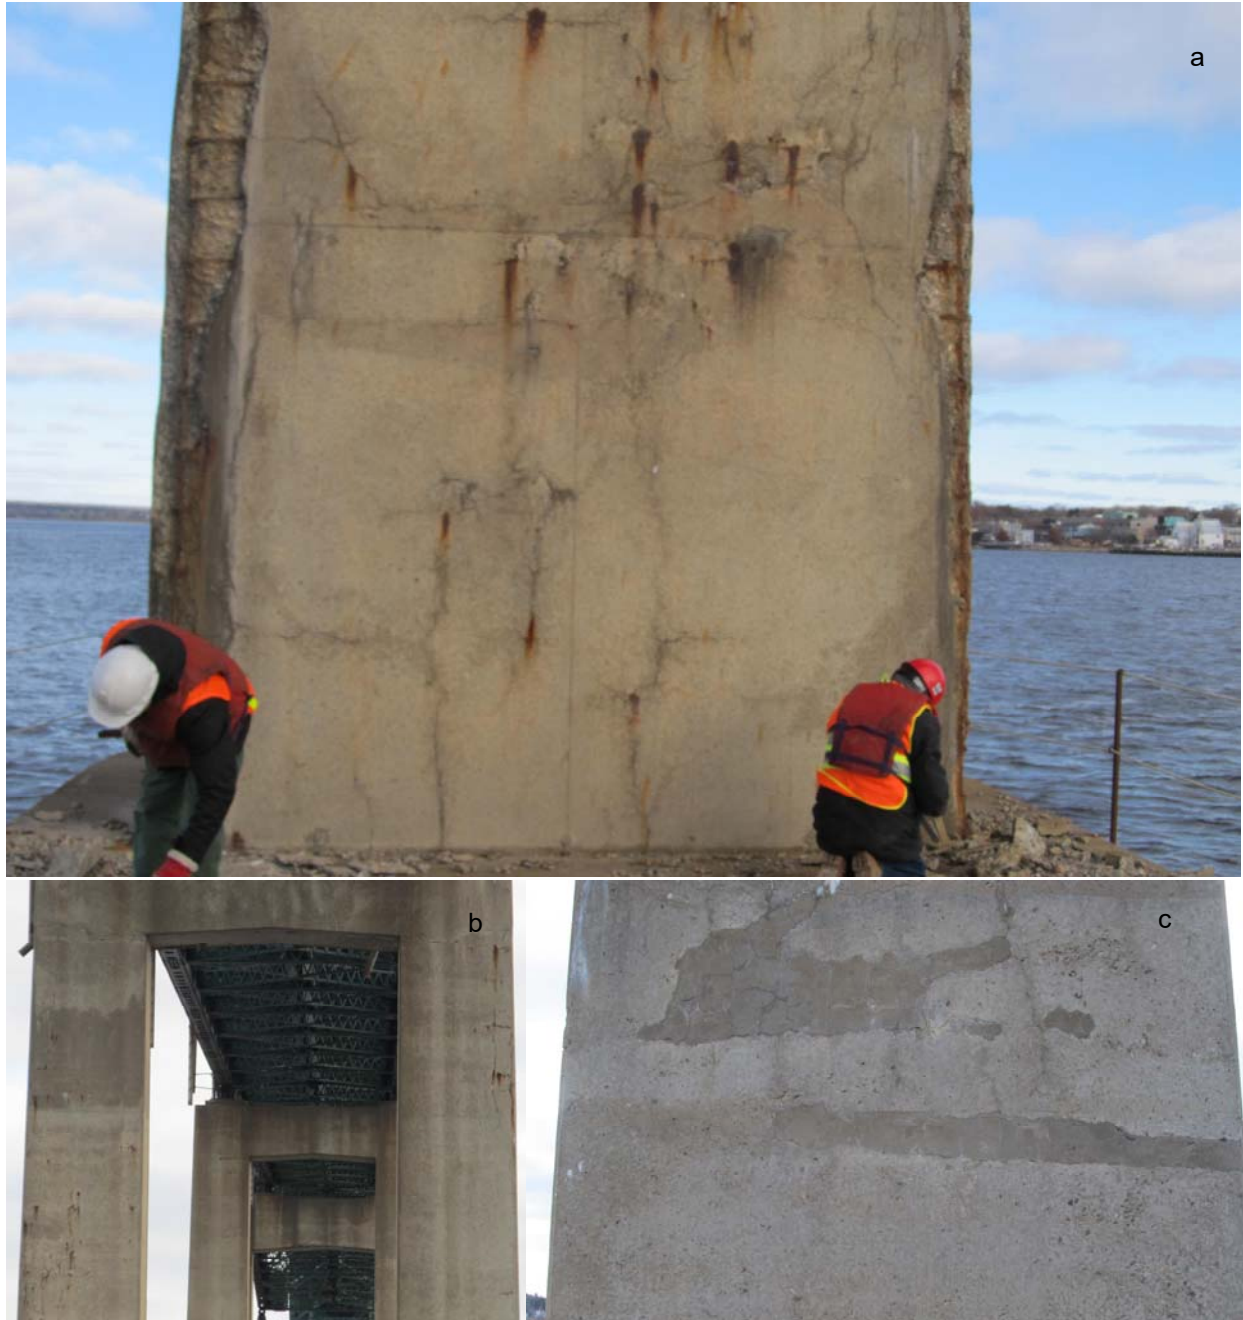
The visual assessments of the substructures revealed a large range in the conditions of the substructures. Several of the piers appeared to be in excellent condition with little to no signs of deterioration despite over 40 years of harsh winter exposure. Other substructures exhibit loss of section and numerous cracks, many of which exhibit seepage of corrosion products (Figure 3a and 3b). Some minor map cracking was also noted. Furthermore, large areas of patched poorly-consolidated concrete were noted at several of the river piers (Figure 3c).

In general, the delamination is most extensive on the southern faces of the piers; however several exceptions exist. For example, approximately 30 – 40% of the north face of pier 10 produced a hollow sound. Pier 10 supports the navigation span and it does not underlie an expansion joint. A deck drain discharges near the northern side of Pier 10 and the concrete cover is reduced, relative to some of the other faces of the piers, on this face. It's suspected that the discharge from this drain impacts the pier, leading to chloride-induced corrosion and the reduced concrete cover has made this face of the pier vulnerable to premature corrosion.

Figure 3: Examples of Deterioration Observed. a) Corrosion and Corrosion-Induced Loss of Section, Pier 11; b) Cracking with Visible Corrosion Product Seepage, Pier 13; c) Improperly Repaired Honeycombing, Pier 11

- Honeycombed concrete with some patching was observed at several locations on the river piers. These areas need to be repaired properly.
- Insufficient cover, likely caused by movement of the reinforcing steel cage relative to the concrete forms, was noted at several locations.

- This includes large patches in some areas and full jackets (entire pier) in other locations.
- Honeycombed areas should be excavated and replaced with suitable concrete properly doweled into the underlying concrete.

- The concrete in the delaminated areas should be excavated to a depth of at least 25 mm beyond the reinforcing steel and replaced with suitable, properly-bonded concrete.

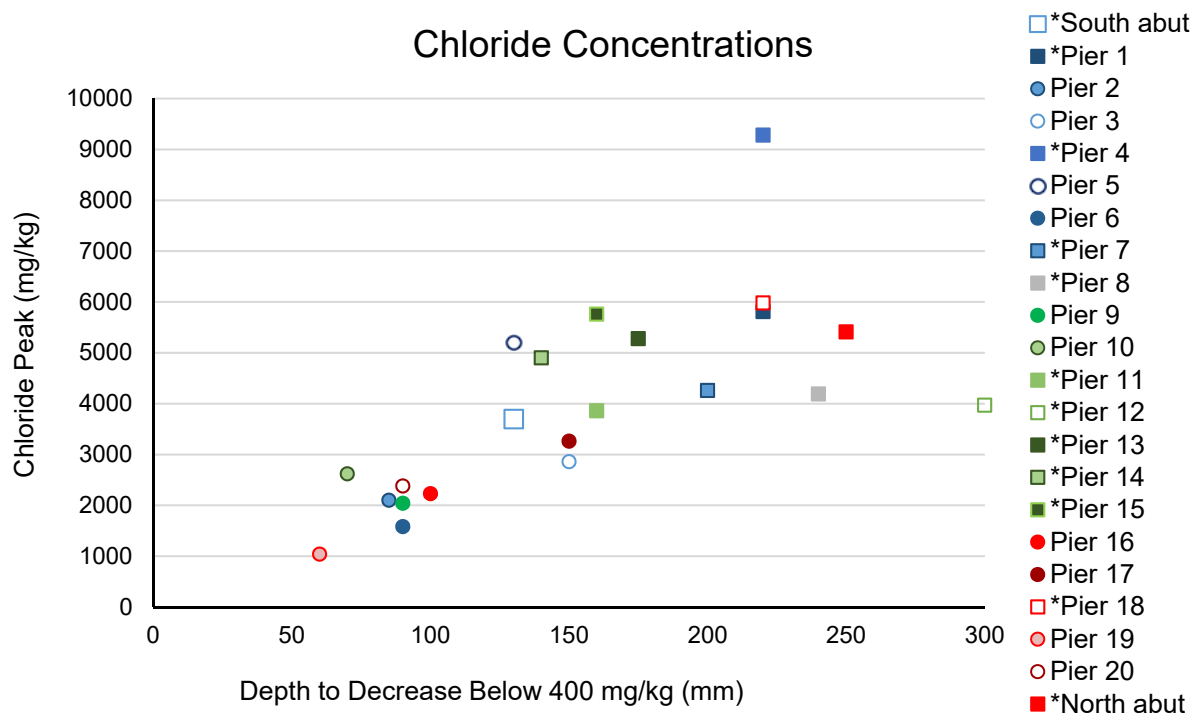
The substructures with overhead expansion joints are identified in Figure 4 with an asterisk (*) in the legend and a square symbol in the plot; those which do not underlie expansion joints are indicated with a circular marker in the plot. The river piers are represented by green coloured symbols and the substructures on the southern and northern shorelines are represented in blue and red, respectively.

Figure 4 clearly demonstrates the correlation between higher chloride ion concentration in the substructures underlying expansion joints (square symbols) as opposed to those which do not underlie expansion joints (circular symbols). The Figure also demonstrates the variability among the different substructures of the

same bridge and it demonstrates that, despite the absence of expansion joints at ten of the twenty pier locations, chloride concentrations in excess of the widely-accepted corrosion threshold were measured in each of the piers.

Figure 4: Peak Chloride Concentration as a Function of Depth to Decrease below 400 mg/kg (mm)

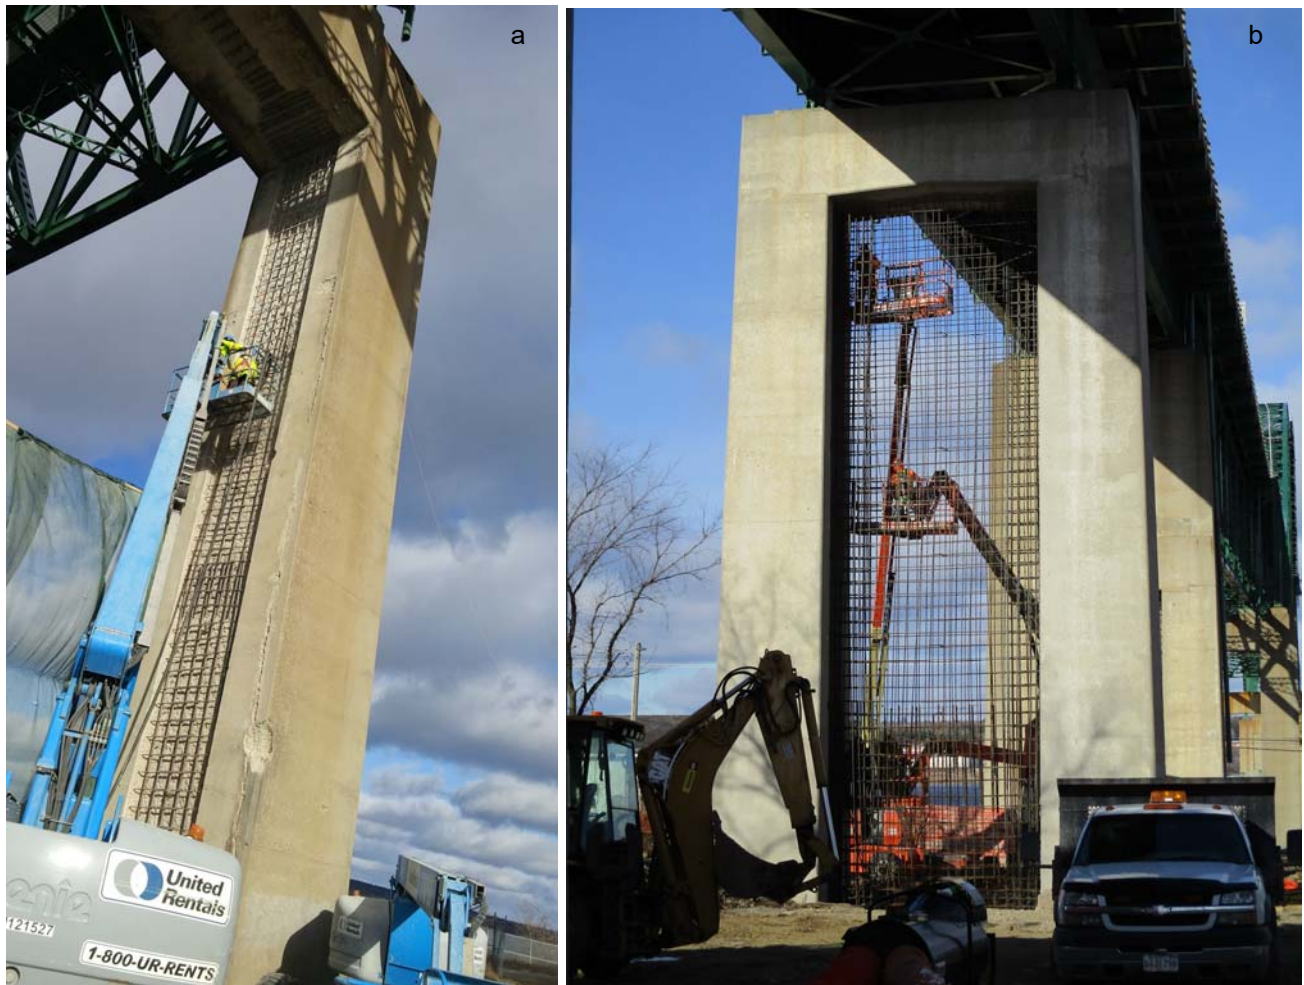
To install the shear walls, the concrete on the interior faces of the pier columns is excavated in the affected area and the exposed reinforcing steel is replaced or repaired as necessary (Figure 5a). Horizontal dowels are installed in the existing columns and vertical dowels are installed at the undersides of the cap beams and in the existing pier bases in order to provide an integral connection between the new and existing structural elements (Figure 5b). Following the construction of the shear walls, the other faces of the columns and pier cap are rehabilitated in a phased process which ensures that the structural integrity is preserved throughout construction.

Figure 5: Pier Rehabilitation Underway a) Concrete Excavation and Steel Renewal in Preparation for Infill Wall; b) Construction of Reinforcing Steel Cage for Infill Wall
