## CIRCULAR CONCRETE COLUMNS REINFORCED WITH STEEL AND GFRP UNDER SIMULATED EARTHQUAKE LOADS

**Abstract:** To address the issue of corrosion of steel in concrete structures, GFRP is slowly gaining acceptability as a replacement of steel. In an effort to evaluate the feasibility of GFRP bars and spirals as internal reinforcement in columns, an extensive research program is underway at the University of Toronto. A total of seventeen 356 mm diameter concrete columns have been tested under simulated earthquake forces which included constant axial load and cyclic lateral displacement excursions. All columns were reinforced laterally with GFRP spirals. Nine columns contained longitudinal GFRP bars while eight had longitudinal steel bars. Results from a select group of specimens are presented in this paper in the form of moment vs. curvature response and shear vs. lateral deflection behaviour. A number of ductility parameters related to curvature, displacement, and energy dissipation are used to evaluate the performance of specimens. Columns containing longitudinal and lateral GFRP reinforcement demonstrated a stable post elastic response accompanying large deformability. Columns reinfor

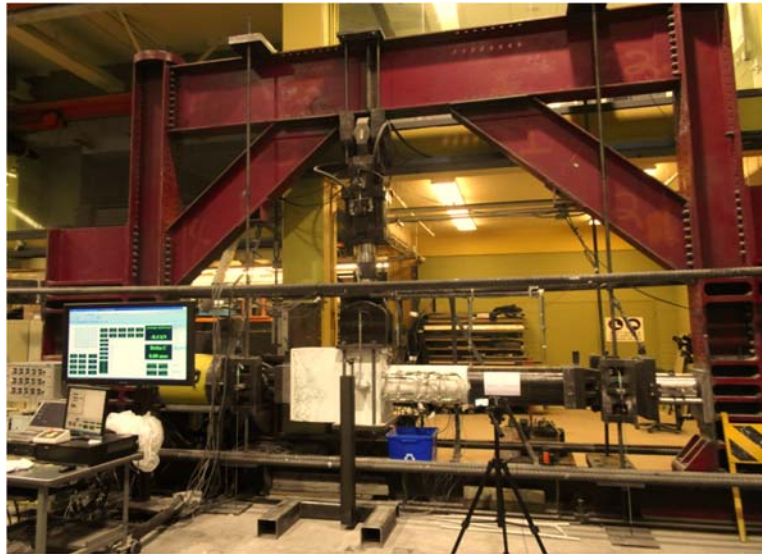
Column Testing Frame (CTF), shown in Figure 3, was used for testing of specimens. The specimen were tested horizontally and subjected simultaneously to a constant axial load and cyclic quasi-static lateral displacement excursions. Figure 4 displays the lateral displacement protocol for testing of columns. The peak displacement of the first cycle was  $0.75\Delta y$ , followed by two cycles each one to  $\Delta y$ ,  $2\Delta y$ ,  $3\Delta y$ , and so on. The nominal yield deflection,  $\Delta y$ , was calculated to be approximately 4 mm. An axial load of 1243 kN ( $0.28P_0$ ) or 1775 kN ( $0.41P_0$ ) was applied to group 2 columns in this project.  $P_0$  is the nominal axial load capacity of column. Axial load was kept constant at the required level during the entire test. Lateral load was applied at the stub (approximately 150 mm away from the stub-column interface), so that the most critically loaded region of the column was adjacent to the stub and subjected to combined flexure, shear, and axial loading. Figure 5 presents a schematic drawing of a specimen in the horizontal test set up and it's relation to a portion of a column standing vertically in a real life application. The actual shear span of column is 1840 mm which extends from the stub-column interface to center of the right steel hinge. The shear span to depth ratio of the column was thus 5.17, where depth was defined as the outside column diameter.

Figure 2: Column Testing Frame (CTF)

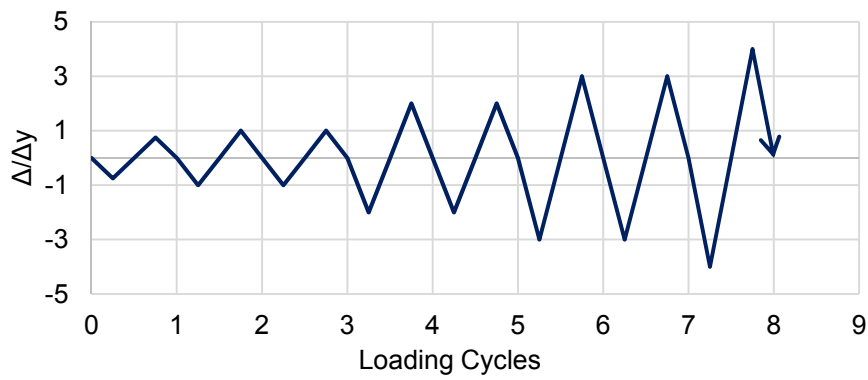
Figure 3: Lateral load excursions

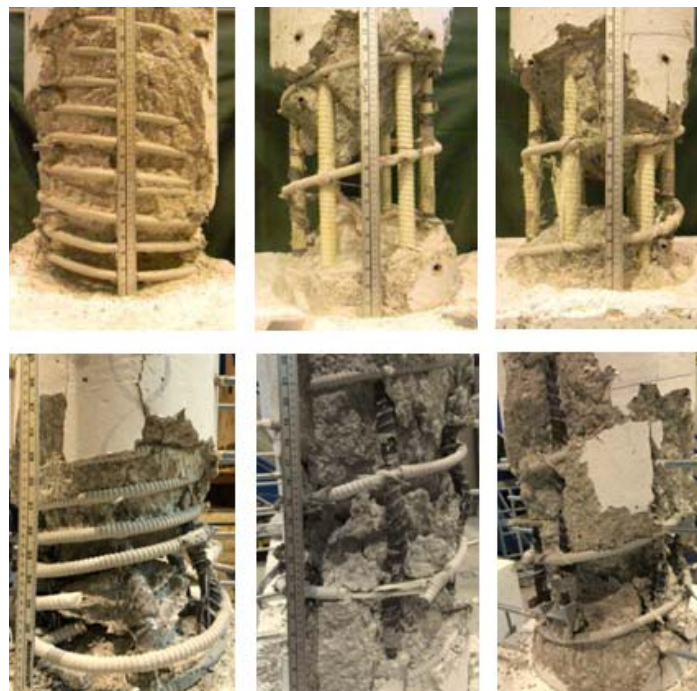
The confinement provided to the core concrete and the support provided to the longitudinal bars vanishes as soon as the GFRP spiral is ruptured. A combination of buckling of the longitudinal bars in compression accompanied by the crushing of the concrete core in the most damaged zone led to termination of the test. Figure 5 shows the most damaged regions for the six specimens discussed here.

Figure 5: Columns after testing (in clockwise direction, starting from top left): P28-C-12-50, P28-C-12-160, P42-C-12-160, P28-LS-12-160, P41-LS-12-160, and P28-LS-12-50

In group 1 specimens, the next main event was failure of the specimen. Lateral load was increased until the column was not able to hold the applied axial load. A combination of crushing and buckling of longitudinal GFRP bars in compression accompanied by crushing of concrete core in the most damaged zone led to a drop in axial load and termination of the test. No rupture was observed in the spirals.

In group 2 specimens, longitudinal steel bars buckled prior to rupture of GFRP spirals in columns with spiral pitch of 160 mm. In the specimen with spiral pitch of 50 mm, longitudinal bars buckled after spirals ruptured. The concept of premature buckling in longitudinal steel bars has been observed previously in square and rectangular columns (Bayrak and Sheikh 2001). They demonstrated that premature buckling could be prevented under cyclic loading only if the  $S/d_b$  ratio was no more than 6. This ratio indicates that premature buckling of a 25M bar occurs if the spiral pitch is greater than 150 mm which matches with experimental results from these tests.

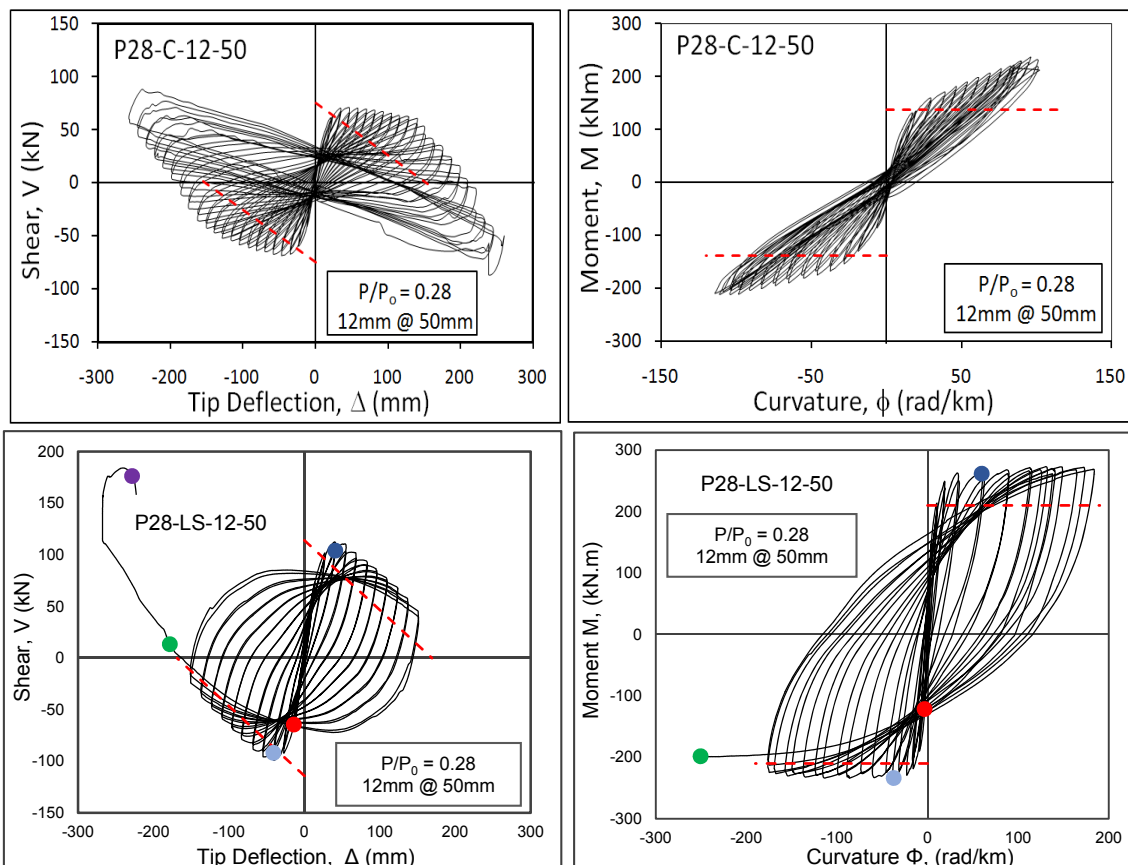
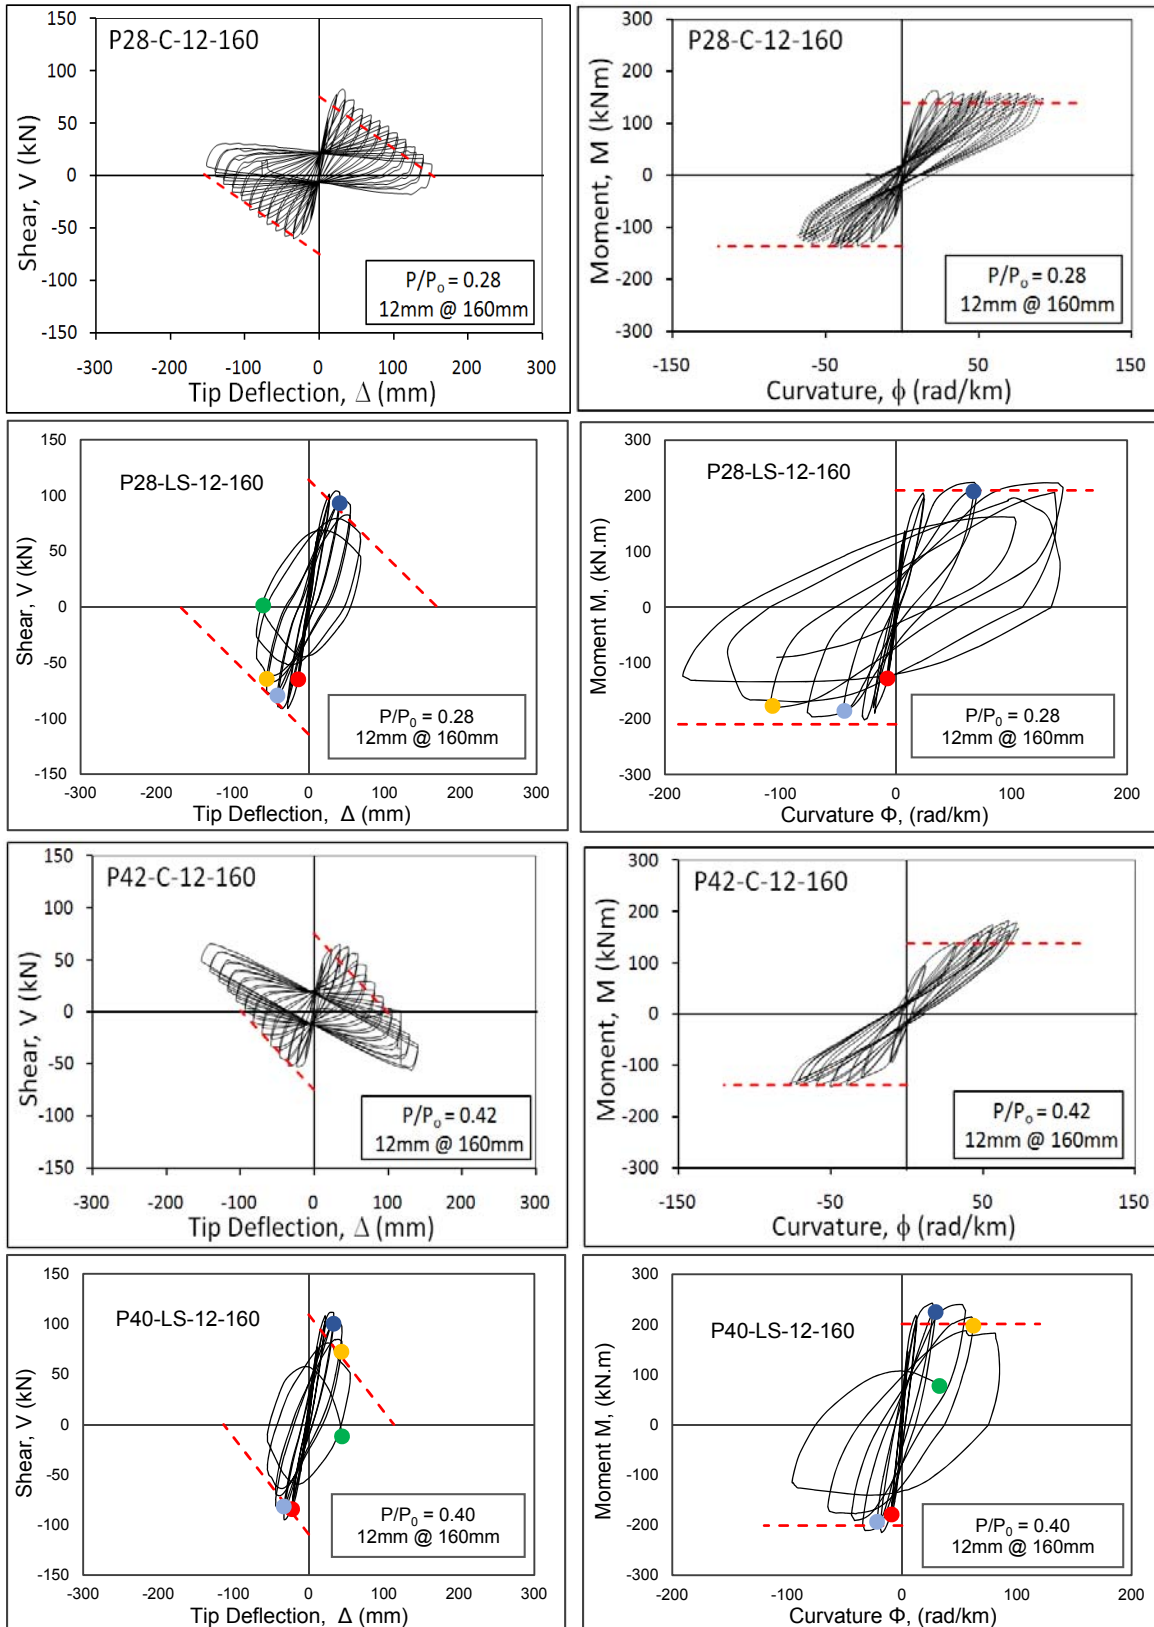
Shear ( $V$ ) vs. tip deflection ( $\Delta$ ) and moment ( $M$ ) vs. curvature ( $\Phi$ ) hysteresis relations for all six columns are shown in Figure 7. The moment-curvature responses shown are for the most damaged sections of the columns. Although the maximum moment occurs at the column-stub interface, the damaged region is shifted slightly away from this interface due to the heavy confinement effect from the stub.

- In group 1 and group 2 specimens:
  - Red horizontal line on the moment curvature response indicates the nominal unconfined moment capacity ( $M_n$ ) of the section; compressive stresses in the longitudinal GFRP bars are also accounted for in the calculation of  $M_n$  in group 1 specimens
  - Sloped red line on the  $V - \Delta$  represents the nominal shear capacity  $V_n$  with a decreasing slope caused by secondary  $P - \Delta$  effects.
- In group 2 specimens:
  - Red dots indicate the initiation of small cracks up to 0.3 mm in width.
  - Light blue and dark blue dots represent the start of concrete cover spalling at bottom and top surfaces, respectively.
  - Green dots signify the rupture of spiral
  - Orange dots indicate that the longitudinal bar(s) had buckled
  - Purple dot indicates the shearing of longitudinal steel bar

Figure 6: Shear vs. deflection and moment vs. curvature relations

It is important to note that curvature in group 1 specimens is developed using the readings provided by the strain gauges installed on longitudinal bars, especially at large deformations, due to the fact that LVDTs became loose during the loading while in group 2 specimens, LVDTs measurements were used. The strain gauge readings in Group 1 specimens may have missed areas of greater deformations resulting in relatively lower curvature values.
