## **SURVIVING THE EARTHQUAKES OF NEW ZEALAND – HOW ADVANCED COMPOSITE RETROFIT TECHNIQUES PROVIDED RESILIENT INFRASTRUCTURE**

On November 14, 2016 the **M7.8 Kaikoura earthquake** hit near Wellington New Zealand and set off over 900 aftershocks. We received word that the severe ground displacements had caused damage to areas that contain structures that had been retrofitted with our advanced composite systems. Our local personnel surveyed some of the damage near an office building that was affected. The office building, Shed 39, not only survived the event, but was also fit to remain in service. An adjacent building that was only 10-years old will be demolished due to the sustained damage and several other nearby buildings were taken out of service due to safety concerns. The retrofit of the building included unique detailing that involved advanced composite anchors along with a technique to allow for movement across construction joints. We have sent our engineers to inspect several other structures in the area that were also retrofitted with our advanced composite systems and to work with the local engineers to learn from these events. This presentation will highlight the buildi

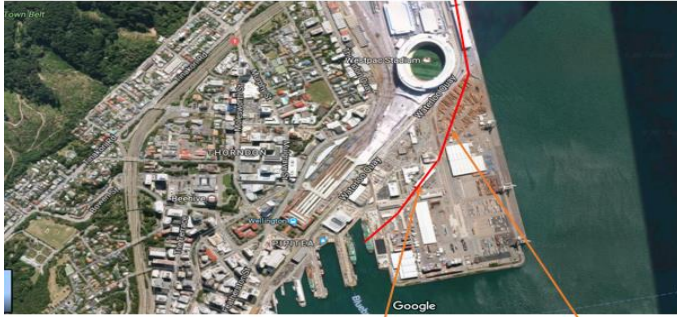
Shed 39 and several other structures are located near Wellington harbor where substantial ground motion was experienced and fault ruptures were evident after the major event.

Approximate location of fault, or ground separation at reclaimed land and wharf structures.

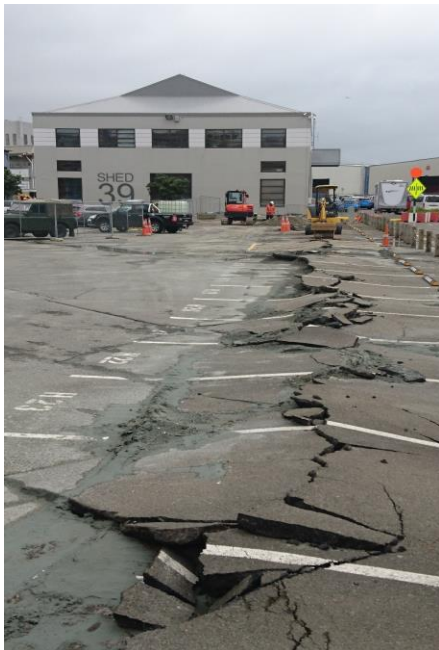
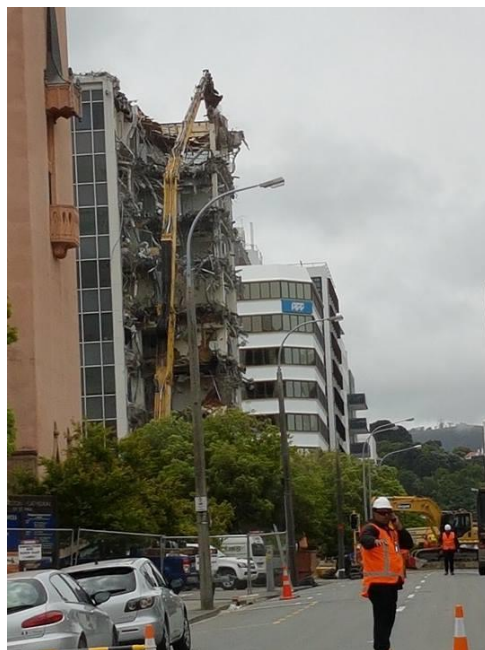
Both of these buildings had seismic retrofits performed prior to the event. Each project utilized advanced composite strengthening with extremely unique detailing. They both required the development of tensile forces with the use of fiber anchors. These carbon fiber reinforced polymer (CFRP) anchors were designed and detailed to transfer the tension forces either into the reinforced concrete or through the concrete to provide continuity. In the case of Shed 39, we provided an alternate detail to that designed by the engineer of record that saved thousands of dollars and also performed as designed in the earthquake. In the case of 81 Molesworth, the anchors were used to properly transfer the tension forces through the beam-column connection.

Both of the highlighted projects proved that the innovative design and detailing would perform as designed while also showing the value of the seismic retrofit compared to the neighboring buildings that were either removed from service, pending repairs, or completely demolished. The photo below shows 81 Molesworth in the background (with the blue sign) while the neighboring building is demolished. It is worth noting that this building was in the process of getting a similar seismic retrofit designed, but it was clearly not in time
