Fredericton, Canada

June 13 – June 16, 2018/ *Juin 13 – Juin 16, 2018*

Experimental Study on Structural Behavior of Concrete Masonry Beams

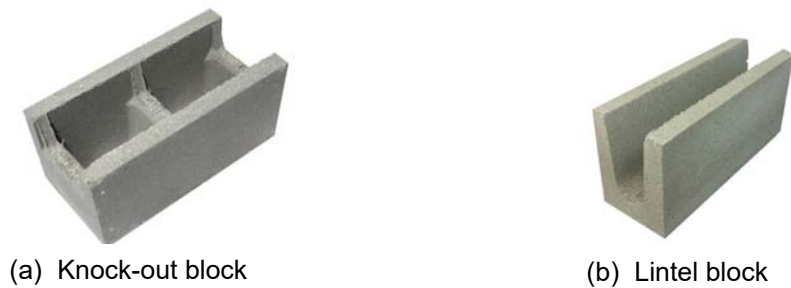
Figure 2. Schematics of lintel block and knock-out units

30-S-N was constructed in stack pattern using 30 cm block units and normal strength grout. The stretcher block units used in constructing these beam specimens had reduced web height and it was done to increase the continuity in the grout in the horizontal direction (Figure 2a). The bottom course of all beams consisted of lintel blocks to facilitate placement of main flexural rebars (Figure 2b).

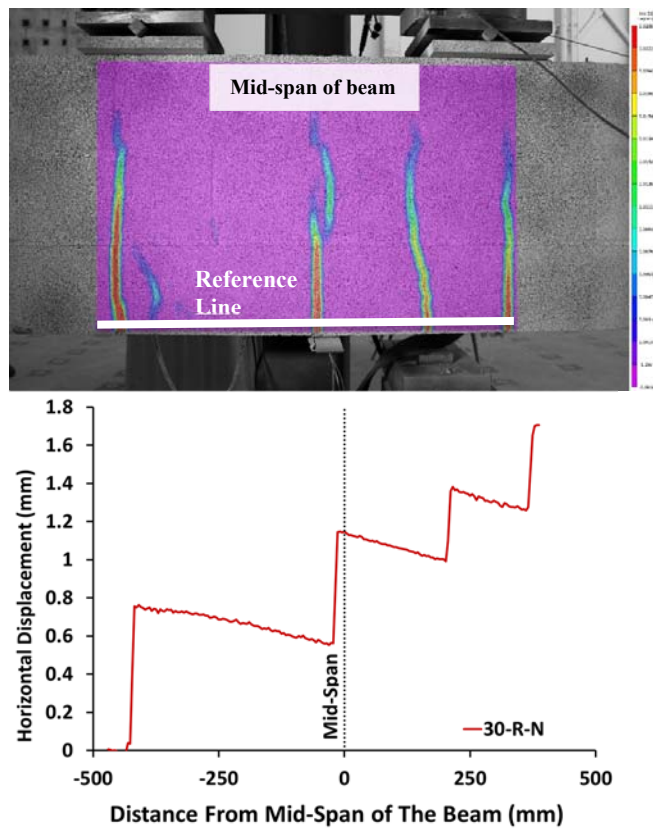
Figure 6: Flexural cracks at mid-span for 30-R-N

DIC technique was used to acquire crack growth data. Figure 6 shows an example on how crack width data was obtained. The crack width data obtained from DIC displacement contour using the method was recommended by Corr et al. (2007). The maximum crack width recorded by DIC for this beam specimen was less than one millimetre which was located very close to the mid-span of the beam specimen

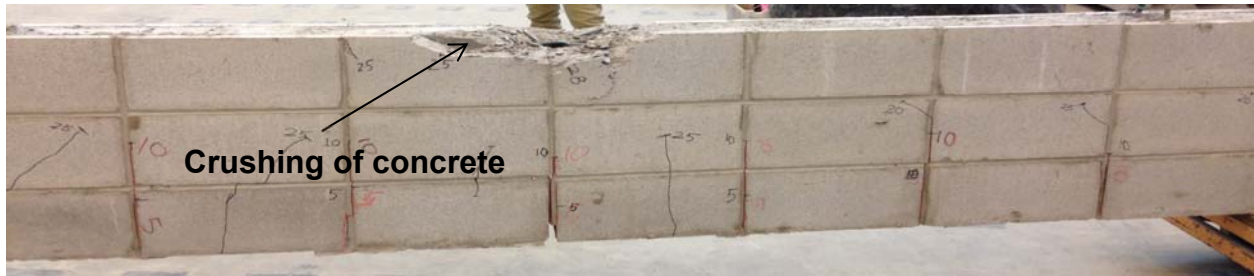
Figure 7: Failure of beam specimen 30-S-N

For both running bond and stack pattern beam specimens, failure occurred due to crushing of concrete at the top surface and at this stage, the test was discontinued (Figure 7).
