Laval (Greater Montreal)

June 12 - 15, 2019

## STUDY OF PRECAST CONCRETE CRAZING DUE TO MOIST CURING

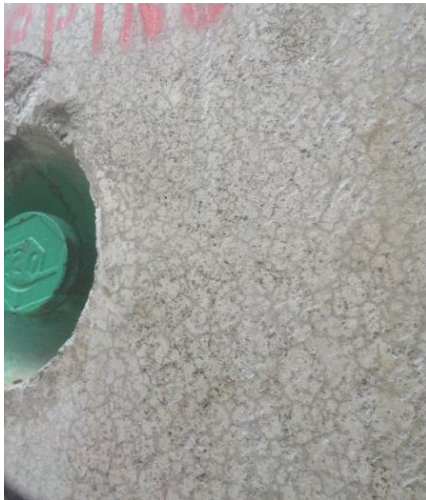
Figure 1: Box culvert surface for Kaskawan Creek, 2015, 96-hour cure by wet burlap and sprinkler

However, the occurrence of crazing in precast concrete could not be found in the open literature. There is perception that when concrete is produced in a controlled environment, precautionary actions in protecting concrete against the loss of moisture are taken, and hence crazing would not occur. Field inspection was conducted in 2015 on several precast concrete box culvert units (**Figure. 1**) after production and before final placement. The product was made using self-consolidating concrete (SCC) and cured in steel molds under controlled environment, followed by 96-hours of wet curing. The extended curing included full enclosure using two-layers of burlap with continuous sprinkling using portable water. Crazing pattern on the vertical concrete faces was accidentally observed in a rainy day and was nearly invisible on dry sunny days. No further action was taken to investigate the crazing because these units

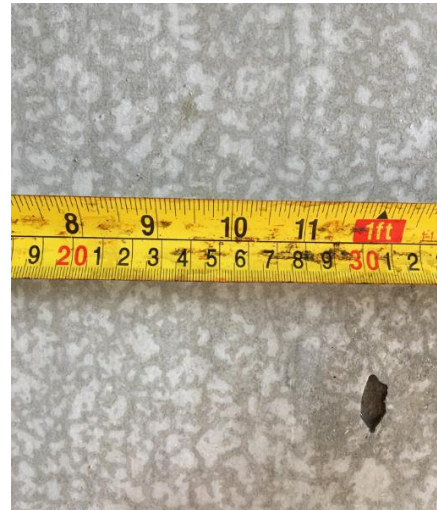
Figure 2: Box culvert surface Meatbird Creek, 2018, 96-hour cure by water immersion

met all contractual requirements. Another box culvert project in 2018 exhibited a similar surface crazing pattern (**Figure. 2**) and was discovered in a similar fashion. Like the first case, the crazing pattern became visible upon wetting. This precast box unit was manufactured using the same SCC mixture under the same environment. However, unlike the first case, the units have gone through an extended 96-hour wet curing by immersing in portable water. Core samples retrieved from the precast unit also exhibited the crazing pattern when subjected to wetting (**Figure 3**), though invisible when it was dry (**Figure 4**). Conversely, the same product cured using a curing compound without extended moist curing in accordance with CSA A23.4 exhibited neither surface crazing nor another surface damage. This has led to a further investigation.

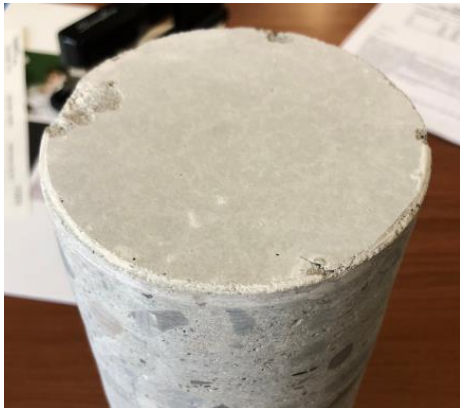
Figure 3: Core sample taken from the box unit from Meatbird Creek Culvert in dry state

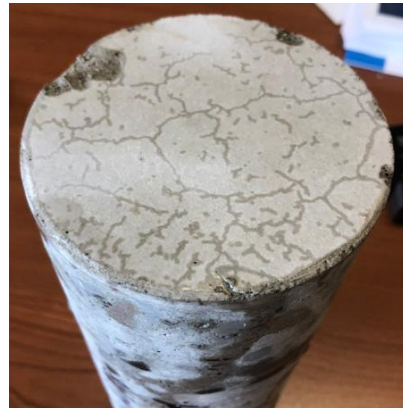
Figure 4: Core sample taken from the box unit from Meatbird Creek Culvert in wet state

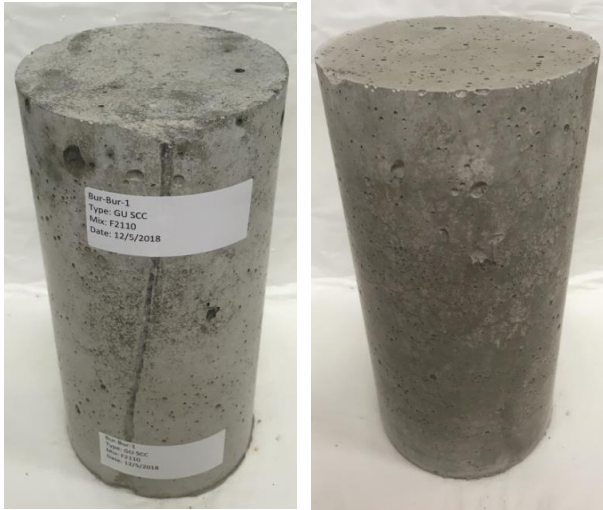
Figure 5:  
(left) GUSCC1-BurBur, (right) GUSCC1-WA

It can be observed that specimens from all mixtures did not exhibit any surface crazing when ambient curing and ambient drying were used. When lime-saturated bath was used for curing and the drying method was ambient exposure or burlap, moderate levels of crazing appeared, in some cases on the vertical face of cylindrical specimens only. This tended to be more significant in specimens with more accelerated hydration reactions, namely when an accelerating agent was used or when high-early strength cement was used. When lime saturated bath curing was combined with oven drying, severe crazing appeared for the high-early strength cement mixture and moderate crazing appeared in the one incorporating the accelerating agent, while the other mixtures did not exhibit any crazing. Generally, the most severe tendency for crazing was observed when potable water was used for curing, followed by ambient drying or drying under burlap cover, which represents the most common scenario in precast concrete practice. With a few exceptions, severe to moderate crazing appeared. Interestingly, curing in potable water followed by more severe oven drying did not exhibit more severe crazing than the case of potable water curing followed by slower drying. The overall trend is that water curing appears to be the most dominant factor in the appearance of surface crazing. The true mechanism behind this behaviour needs further investigation. It appears at this preliminary stage that when the drying effect takes place very early, such as in the case of ambient curing, the moisture gradient travels deeper in the surface of the concrete that is still more pervious to evaporation due to non-advanced hydration reactions, and likely gets better restrained by aggregates. Conversely, in specimens submerged in water, when the drying action initiates, it only affects a colloidal surface of cement paste, with no aggregate restraint, while the rest of the concrete deeper in the surface is still moist and unwilling to contract, considering that it is less pervious to evaporation due to more advanced hydration reactions. This is further supported by the fact that the more rapid cement hydration reactions are (e.g. when HE cement or accelerating agent are used), the more is the likelihood of crazing and the higher the degree of its severity.

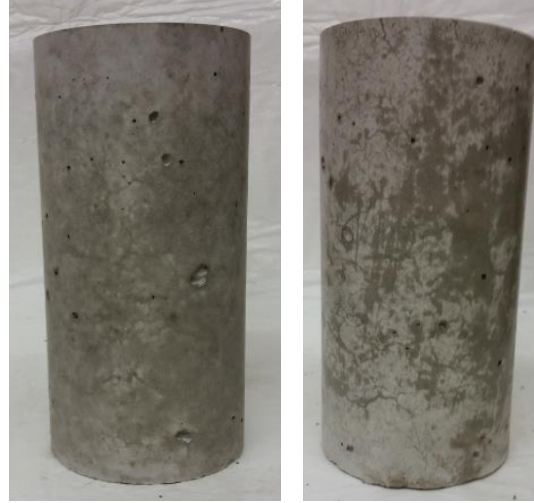
Figure 6:  
(left) GUSLUMP-WA1, (right) GUSLUMP-WBur1

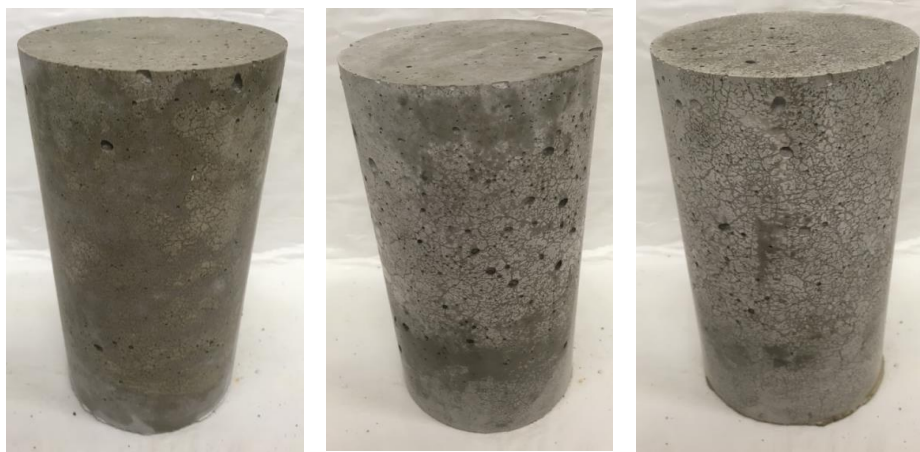
Figure 7: (left) HESCC-BO, (mid) HESCC-WA, (right) HESCC-Bur,

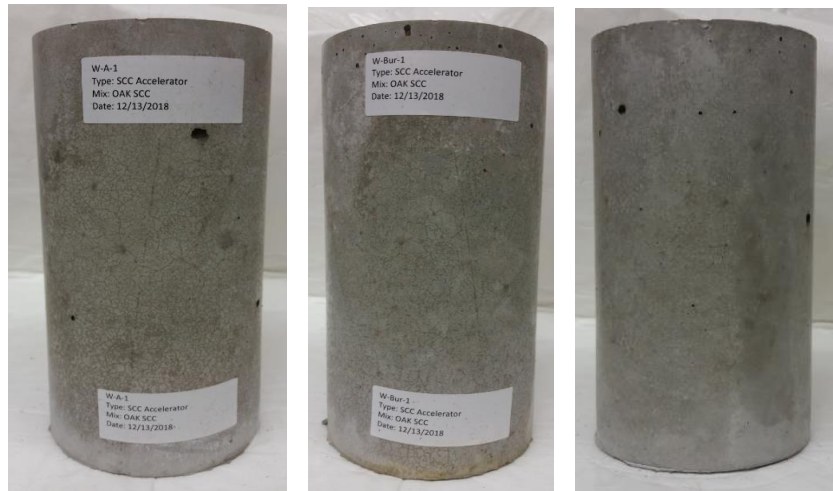
Figure 6: (left) GUSCC2-WA1, (mid) GUSCC2-WBur1, (right) GUSCC2-WO1

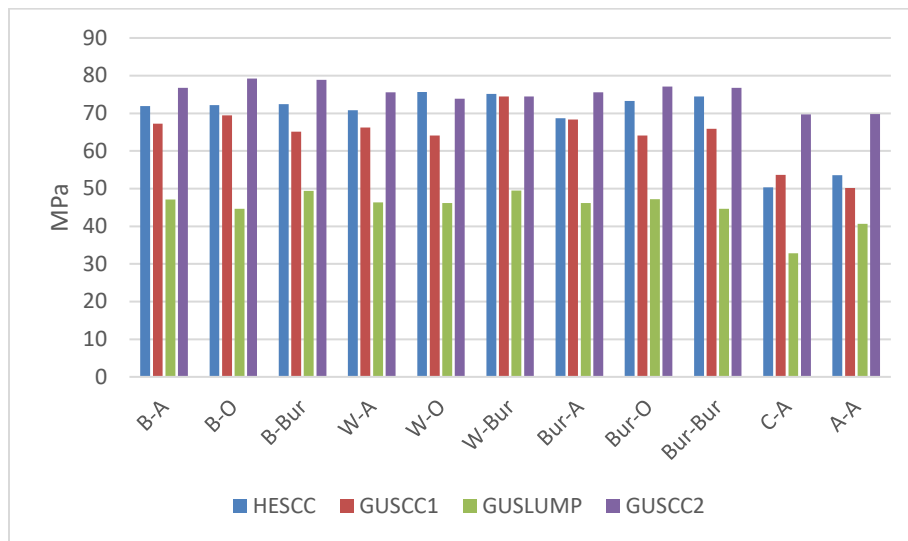
Figure 7: 28-day Compressive Strength versus Curing and Drying Regime.

The effect of the initial curing regime and drying procedure on the 28-days compressive strength of specimens from the different mixtures is illustrated in Figure 9. Generally, there was no significant difference in compressive strength between specimens cured in lime saturated water bath, potable water, or wet burlap. Figure 10 displays the expected trend that curing under more abundant moisture yields generally higher compressive strength. Hence, specimens initially cured in ambient air or coated with a curing compound achieved lower strength results that of specimens submersed in water or which benefited from wet burlap cover to supply external moisture.

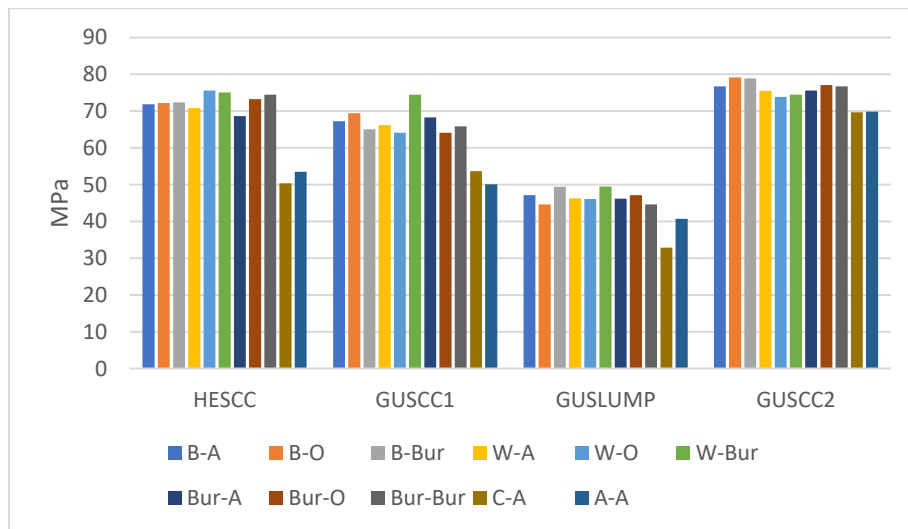
Figure 10: 28-day Compressive Strength Sorted by Mixture Design.

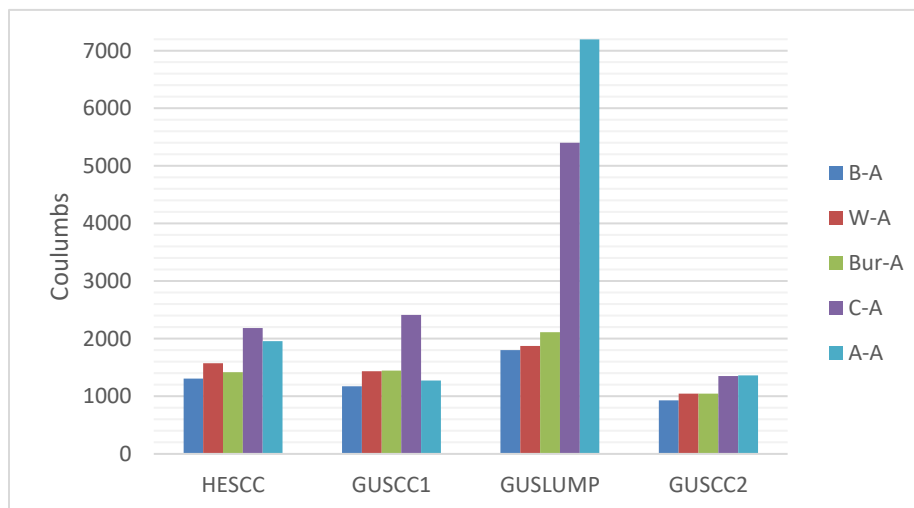
Figure 12: Rapid Chloride Ions Penetrability by Mixture Design.

Rapid chloride ions penetrability (RCPT) test results for all mixtures are illustrated in Figure 11 versus curing and drying regime and sorted out by mixture, for further clarity, in Figure 12. Generally, initial curing in water led to lower RCPT. Ambient curing or using a curing compound were particularly detrimental to the normal slump control mixture, which had much higher RCPT results. It appears then that curing that mitigates surface crazing can compromise more fundamental properties such RCPT.

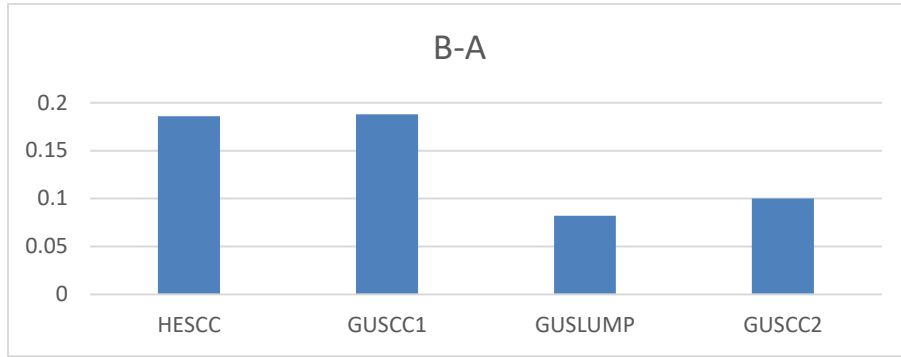
Figure 13: AVS by Mixture Design for Specimens Bath Cured and Air Dried.

Results of microscopical determination of parameters of the air-void system in hardened concrete are portrayed in Fig. 3. The results which are more related to the air void system in the cementitious matrix after setting do not depend on the curing approach or the occurrence of crazing and generally reflect good potential for durability to Freezing and thawing.

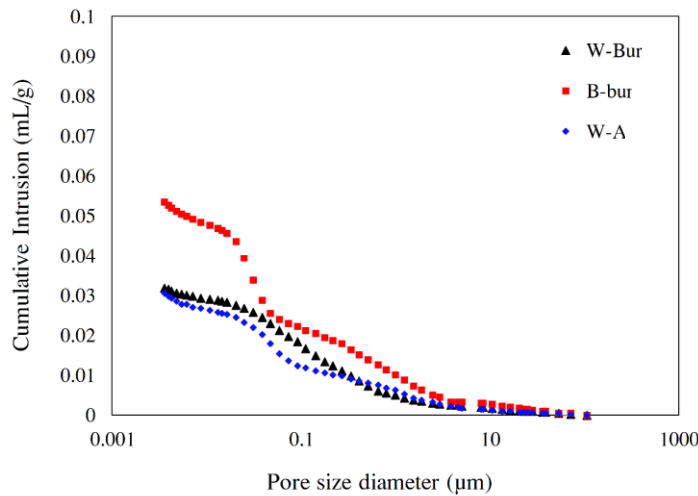
Figure 14 – Example of MIP test results.

Mercury intrusion porosity results showed that moist curing results in generally less intruded pore volume as expected. An example of results is shown in Figure 14. For instance, wet curing demonstrated less pore volume than curing specimens under wet burlap. Optical microscopy observations did not provide additional insight. For instance, Figure 15 shows crazed specimen, without much information on the depth of crazing cracks when present. Hence, it was decided to use X-ray computed tomography to identify crazing cracks in 3-D image analysis. This work is in progress at the time of submitting this article. Other results corroborate to indicate that crazing is rather an esthetic surface problem. However, X-ray micro-CT should provide direct evidence for this.
