AN INVESTIGATION INTO THE RESILIENCE OF GLULAM TIMBER BEAMS AFTER FIRE EXPOSURE

Abstract: A critical element in the design of timber structures is the building's response in the event of a fire. Currently, engineered timber, which relies on complicated adhesives to join wood elements, is used to build up large section sizes for structural assemblies. When not encapsulated and exposed to fire, however, engineered timber mechanically degrades via charring and adhesive breakdown. Understanding this degradation will provide greater confidence for the practitioner for new tall timber designs since it is necessary to better determine the performance of engineered timber under fire exposure, and also to determine the level of reparability required after a fire. Therefore, the present study examines a hypothetical design example as motivation for research into fire response in tall engineered timber construction. The case study prompts the need for demonstrative testing to build confidence in use of exposed (unencapsulated) timber elements. For this, the after-fire performance of engineered timber Glulam beams was considered in comparison to undamaged control beams in twelve, two point, l

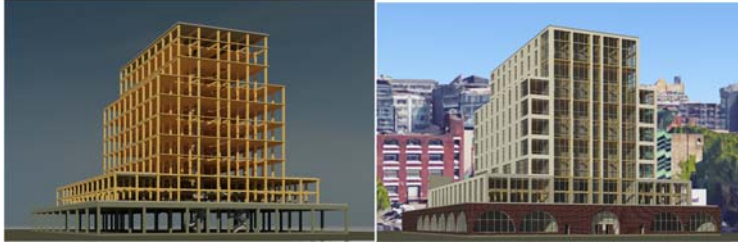
Figure 1: Structure of *Hypothetical A* engineered timber hybrid building (left), and exterior of *Hypothetical A* building (right).

The theoretical structure of *Hypothetical A* can be seen in Figure 1. It is not the intent to provide anything other than a hypothetical rendering of the structure and therefore specific design is omitted. An engineered timber structure can take on many different structural timber configurations. This could, though not limited to, include: Glulam beams and columns, Nail laminated timber slabs, Cross laminated timber cores and partitions. Typical load path configurations in many timber buildings feature a grid shape.

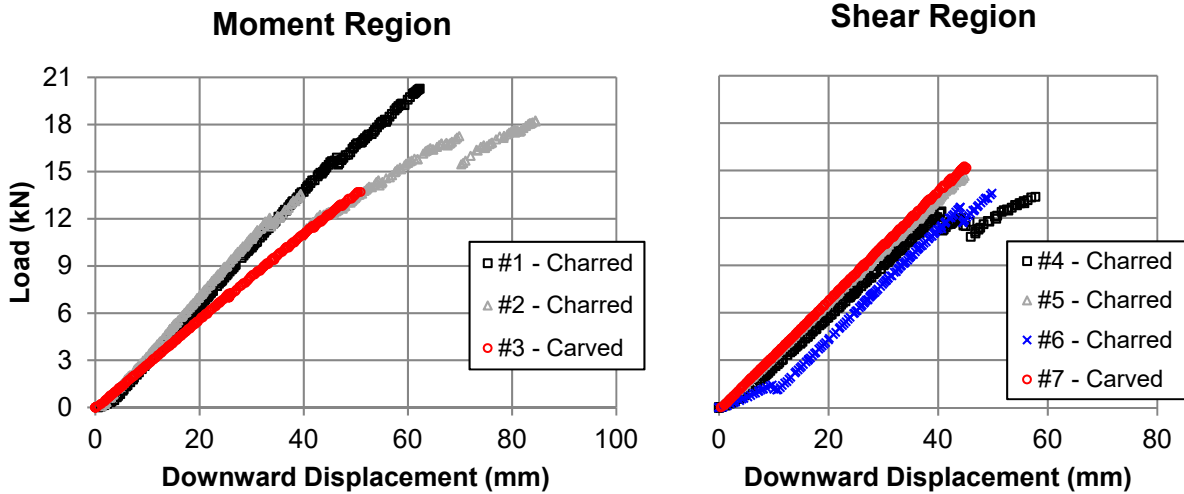
Figure 5: Load versus downward displacement of the carved and charred beams that have been damaged in the moment region (left) and shear region (right)

The stiffness and average failure loads obtained during the mechanical loading are summarized in Table 1. On an average basis, the control beams failed at the highest applied load, with all of the carved and charred beams failing at lower loads. All failure loads were higher than the hand calculated estimated strength (13.6kN). The displacement of the beams as they were mechanically loaded was recorded and is presented in the plots of load versus vertical displacement in Figure 5. Amongst beams damaged in the moment region (midspan), the results were quite variable; the beam with mechanically reduced cross section failed at a relatively low load compared to the charred specimens. Amongst beams damaged in the shear region (towards the side), the beam that had its cross section mechanically reduced through carving displayed the highest stiffness, as the slope of its curve is the greatest, and experienced a higher failure load than any of the charred beams.

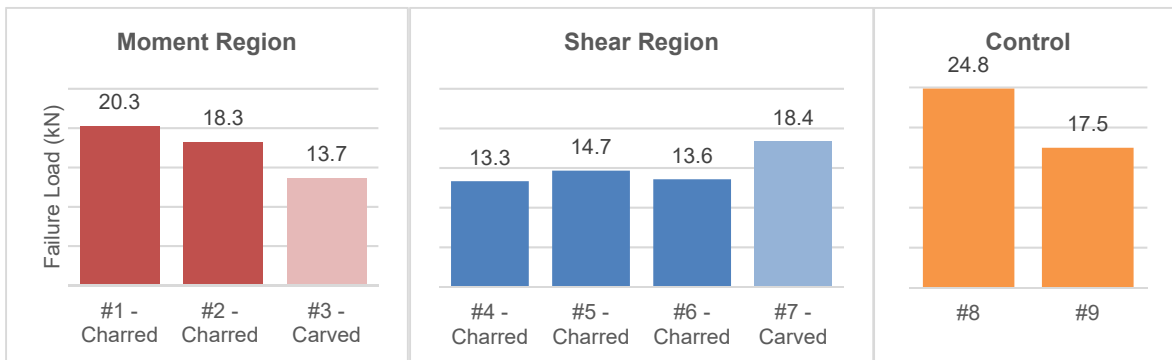
A comparison of the peak load reached by each beam before failure can be seen in Figure 6. The two control beams failed at relatively high loads with the difference possibly due to inherent materials defects between the two specimens. The beams charred in the moment region withstood relatively high loads, in comparison to the beam whose cross section was mechanically carved away which failed at a discernably lower load. In contrast, the beams charred in the shear region failed at relatively low yet consistent values of load, while the mechanically carved beam performed better, and failed at a higher load.

Figure 6. Comparison of the failure load of all beams damaged in the moment region, shear region, as well as the control beams

As anticipated, the control beams had a higher strength and stiffness than the damaged beams since they were full cross section, and no possible damage had occurred due to heating. The beams charred in the moment region performed comparatively to the control beams; their strength was not greatly reduced through heat exposure. The mechanically carved moment beam exhibited a relatively low failure load and stiffness, even in comparison to the charred beams. It is possible that this beam had a material defect that was not visibly apparent, causing the low failure load.

For the shear damaged beams, the beam whose cross section was mechanically carved away failed at a higher load and had a higher stiffness than the charred beams. Since the cross sectional areas for the charred and carved beams were very similar, the reduction in strength and stiffness of the charred beams is indicative of adhesive degradation. It is interesting that the better performance of the carved beam over the charred beams is a trend that only occurred in the set of beams damaged in the shear region. This was not observed in the set of beams damaged in the moment region (assuming the low failure load for the carved beam was not entirely due a material defect). This may indicate that the underlying failure mechanism of the beams was shear induced, or caused by a combination of shear and moment that occurred towards the sides of the beams, as they were loaded. Though not definitive from the present results, this could point to differences in response to fire exposure in regions of high moment versus high shear. This directly affects the design of timber connections, where notches in the shear regions are common, the design of connections would have to be carefully considered.
